W.O. #09-66504-0

Repair Lower Waterwall Tube-to-Header Welds in Unit 2

UDC
Outage Report
U-2 2010

Intermountain
Unit 2
Fall 2010

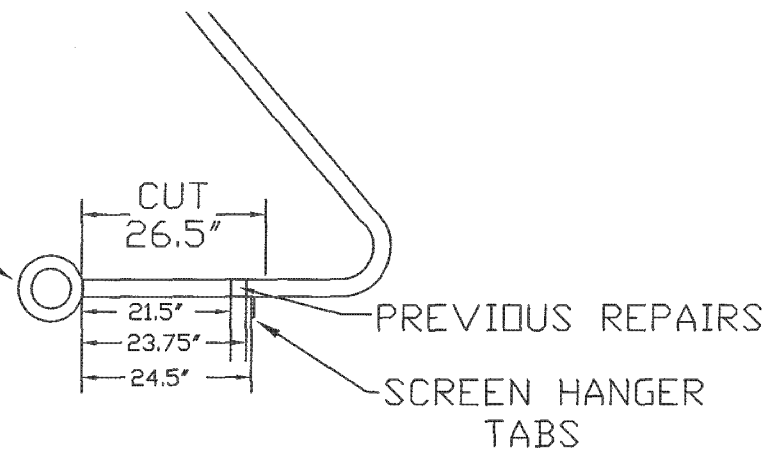
U-2 MEASUREMENTS

NOTE: This drawing is for U-1 & U-2 CUT. U-2 was measured during the 2010 fall outage and found to be different than U-1 measurements taken during the U-1 spring 2010 outage.

LOWER FRONT
WATERWALL HEADER
1.875" THICK
SA 106C MATERIAL

TUBES TO BE CUT OUT & REPLACED
ARE ON HEADERS 6 & 7. MARKED
TUBES TO BE CUT OUT ARE ON HEADER
8. ALL TUBES ARE ON 3" CENTERS.
TUBES 38, 39, 40 & 42 WERE
REPLACED IN 2008 ON HEADER 7 (do
not replace). TUBE MATERIAL IS SA
210 A1 CF 2.5" OD X .270" MW.

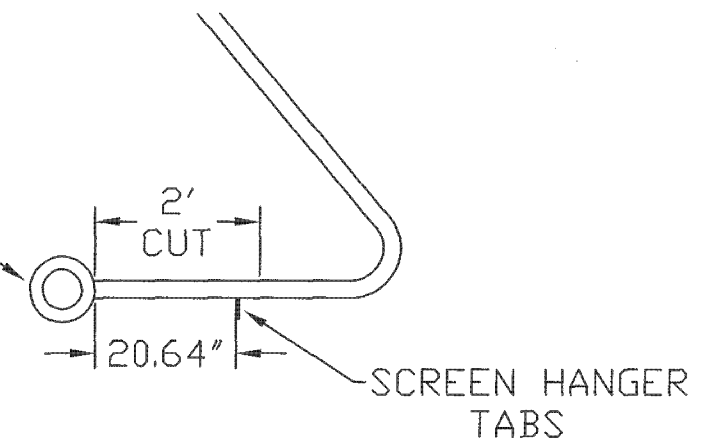
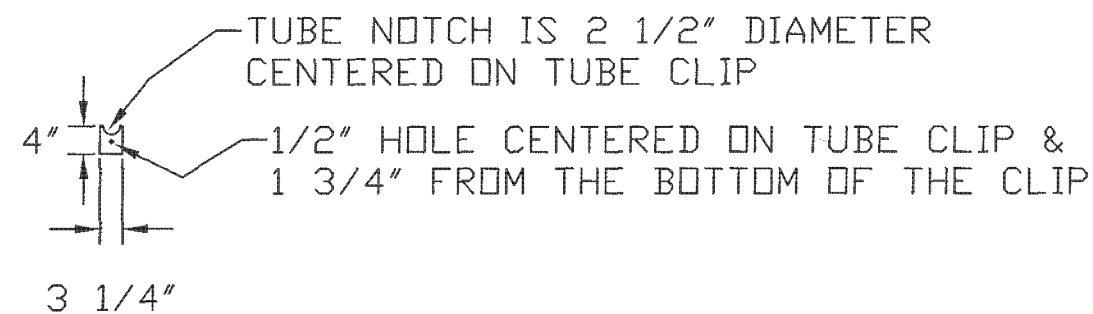
U-1 MEASUREMENTS

LOWER FRONT
WATERWALL HEADER
1.875" THICK
SA 106C MATERIAL

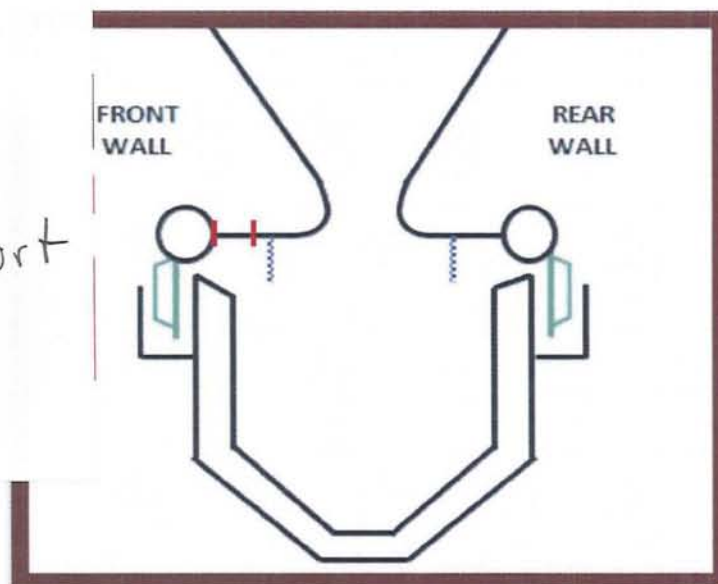
FRONT WW HEADER TUBES

Total welds
168

Total complete
168

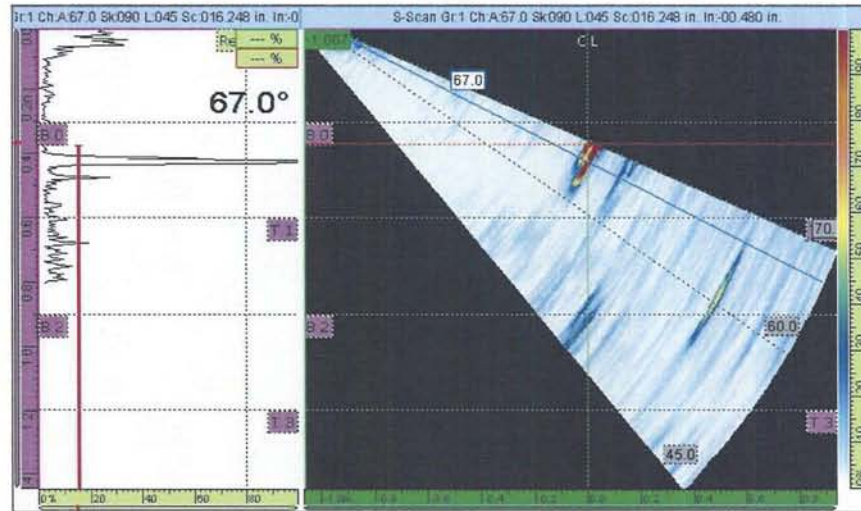
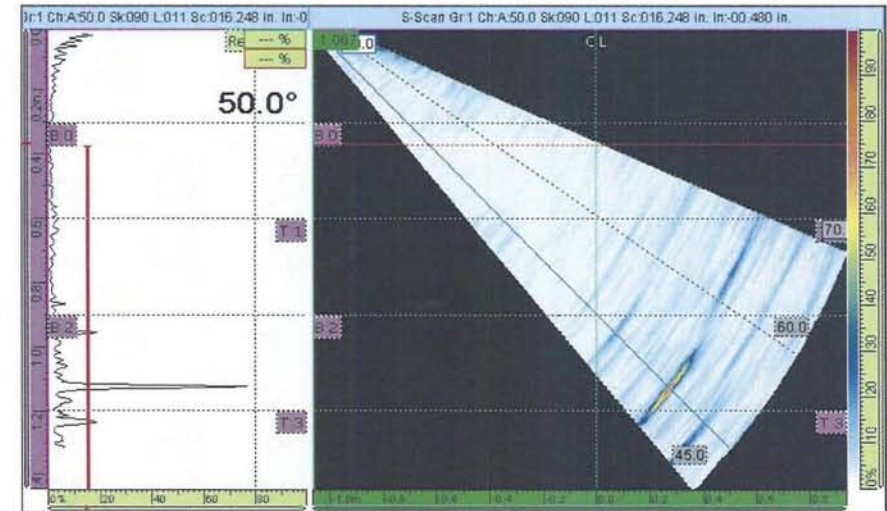
Phased Array Probe 1

Header #	Tube #	Location	Weld pos.	Welder ID	Date Inspected	1st	2nd	3rd	Comment
8	301	Front WW	header stub	0605/2250	1-Nov	OK			MT by 5 Star
8			tube	0605/2250	30-Oct	OK
